Lower Huia Dam

Summary of Dam and Main Elements

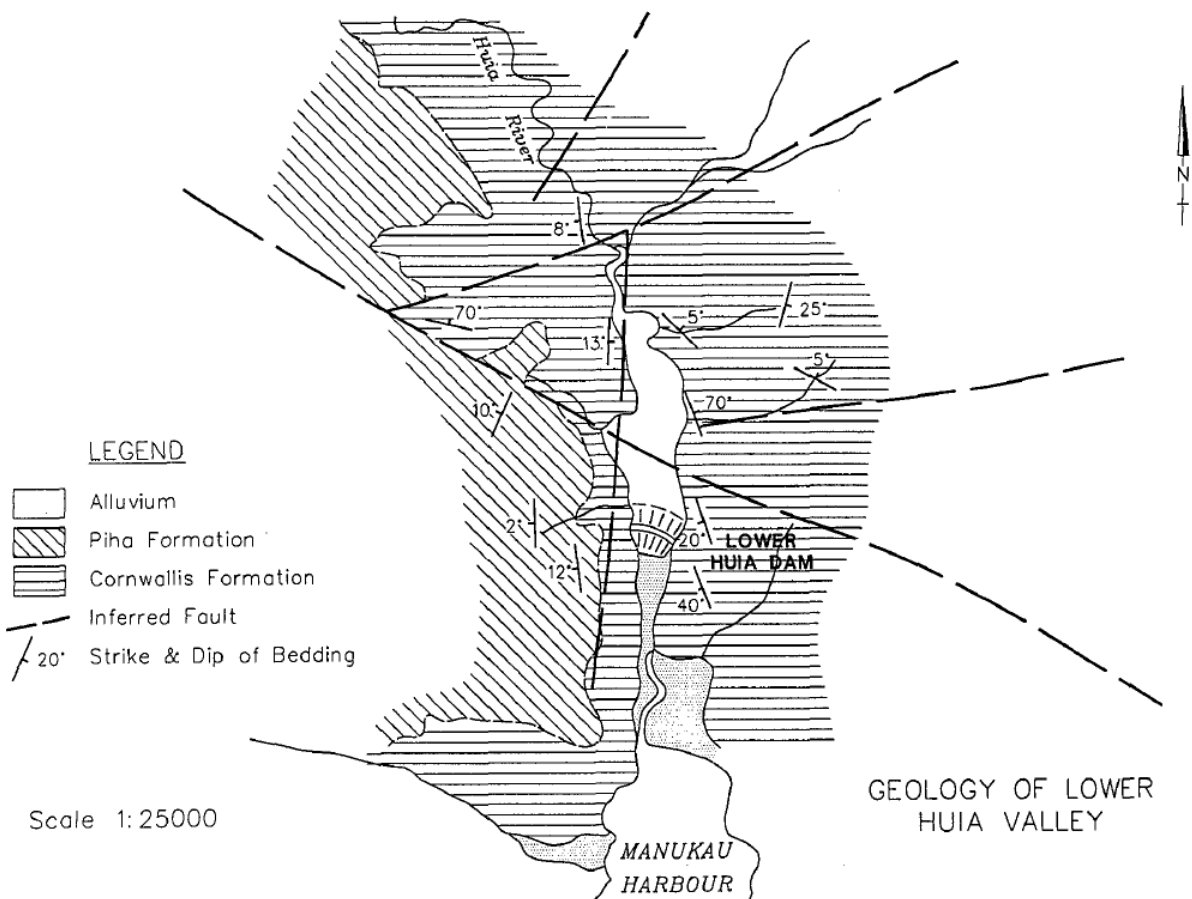
Reservoir Basin

An inspection was made of the reservoir margins at a time when the reservoir was almost full. As a consequence, little could be seen of the drawn-down slopes. Generally, forest vegetation extends down to the water line with the exception of the right (west) side of the reservoir where a drowned old road is located near the reservoir edge. Batters cut for this drowned road has fretted locally causing small, localised, areas of drop outs. Elsewhere along the reservoir margins the slopes above the water line are stable with the exception of the steeper slopes on the left side near the intake tower and bellmouth spillway, as described previously. The slopes above the reservoir adjacent to the intake tower/bellmouth spillway more or less reflect the dip of the underlying sandstone/siltstone bedding and are showing signs of minor planar instability along the reservoir margins due to wave undercutting. These slopes should be inspected when the reservoir is drawn down to assess stability. Apart from localised areas of potential instability (e.g. near left abutment) little risk is seen of substantial slope failure displacing large volumes of water and impacting on dam safety.
