Waitakere main dam hydraulic structure

Schedule of Contents

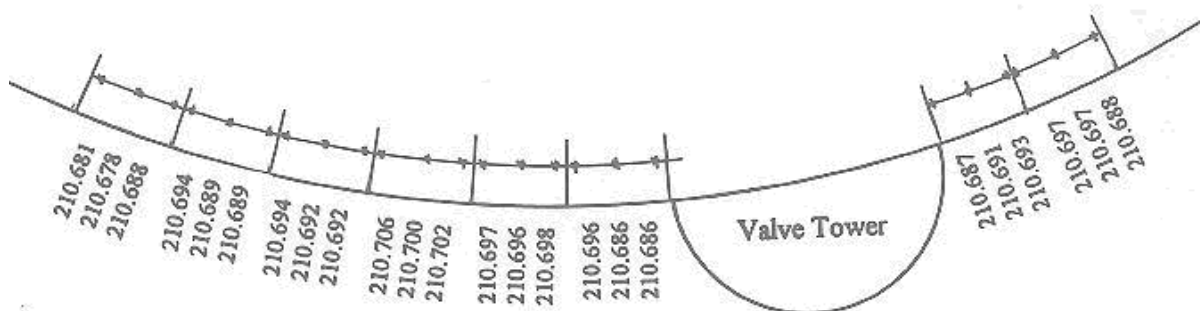
Spillway Crest Levels

Sketch only :- Not to Scale
Levels spaced at 2m intervals in each bay

TO: Wallace McQuarrie
FROM: Phil Salmon
SUBJECT: Waitakere Catchments -- Dam Spillway Levels
(to show construction variation)
DATE: 12 May 1995 FILE:
