Lower Nihotupu Dam

Background and Summary Details

Description of the Dam and Appurtenant Structures

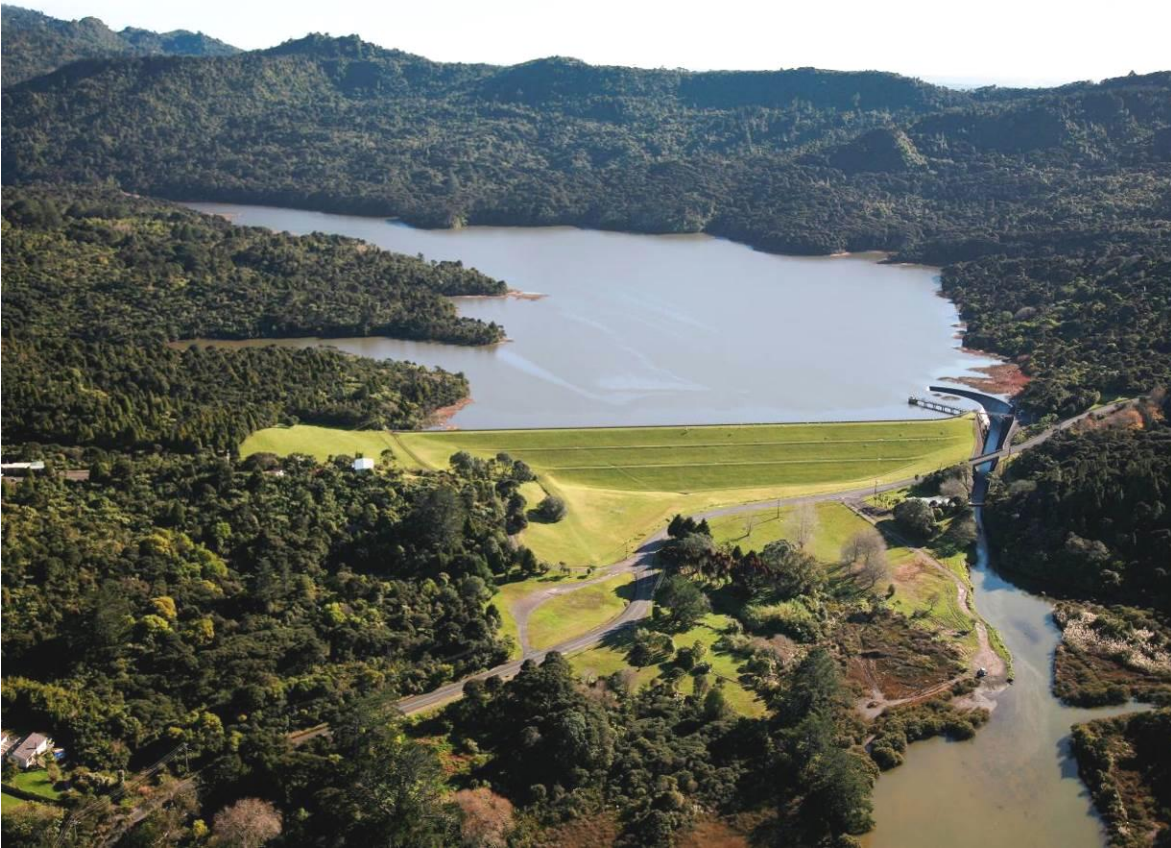
Aerial View of the Lower Nihotupu Dam

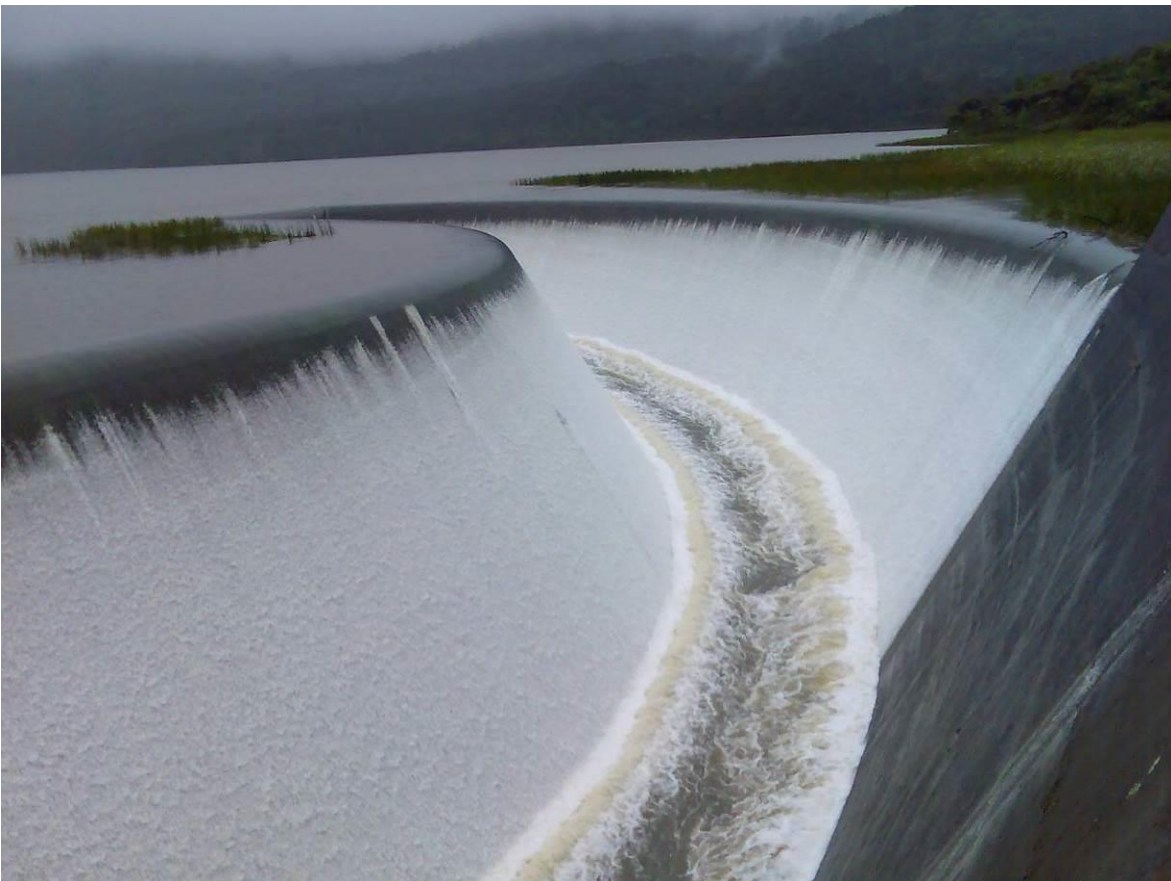
Lower Nihotupu Dam Spillway in Operation

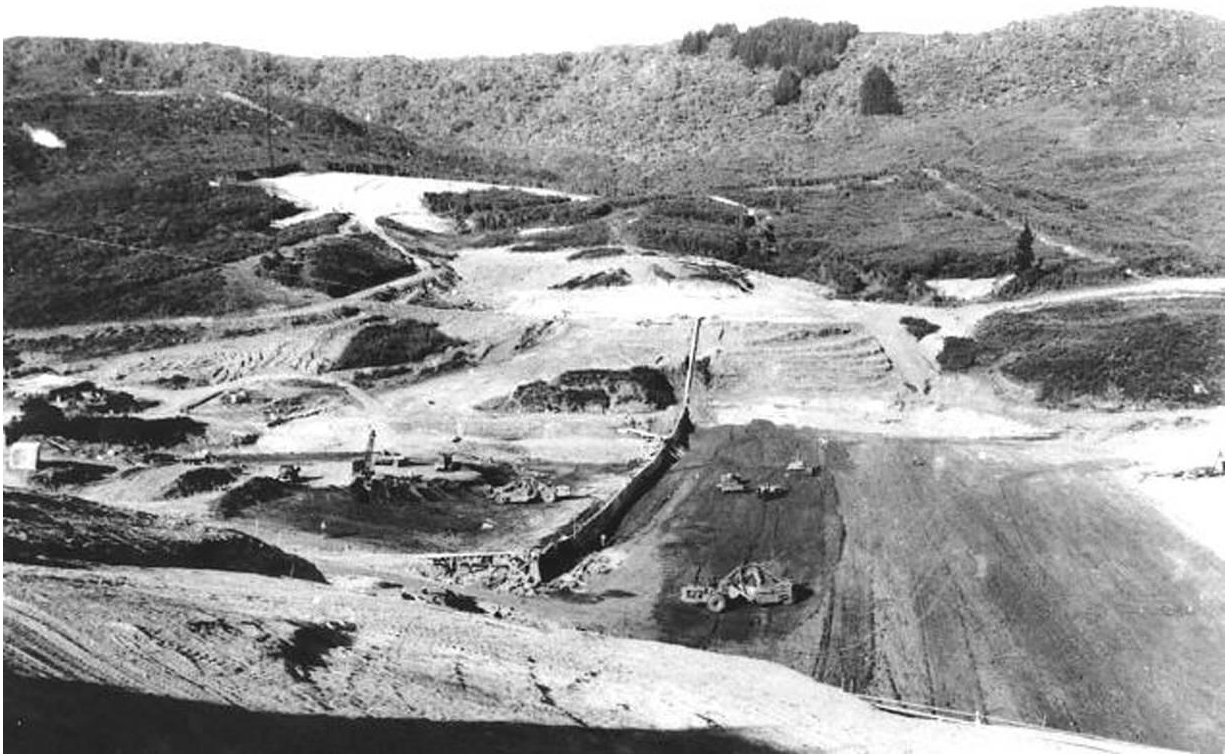
Looking south west along the line of the dam with the cut off wall already constructed

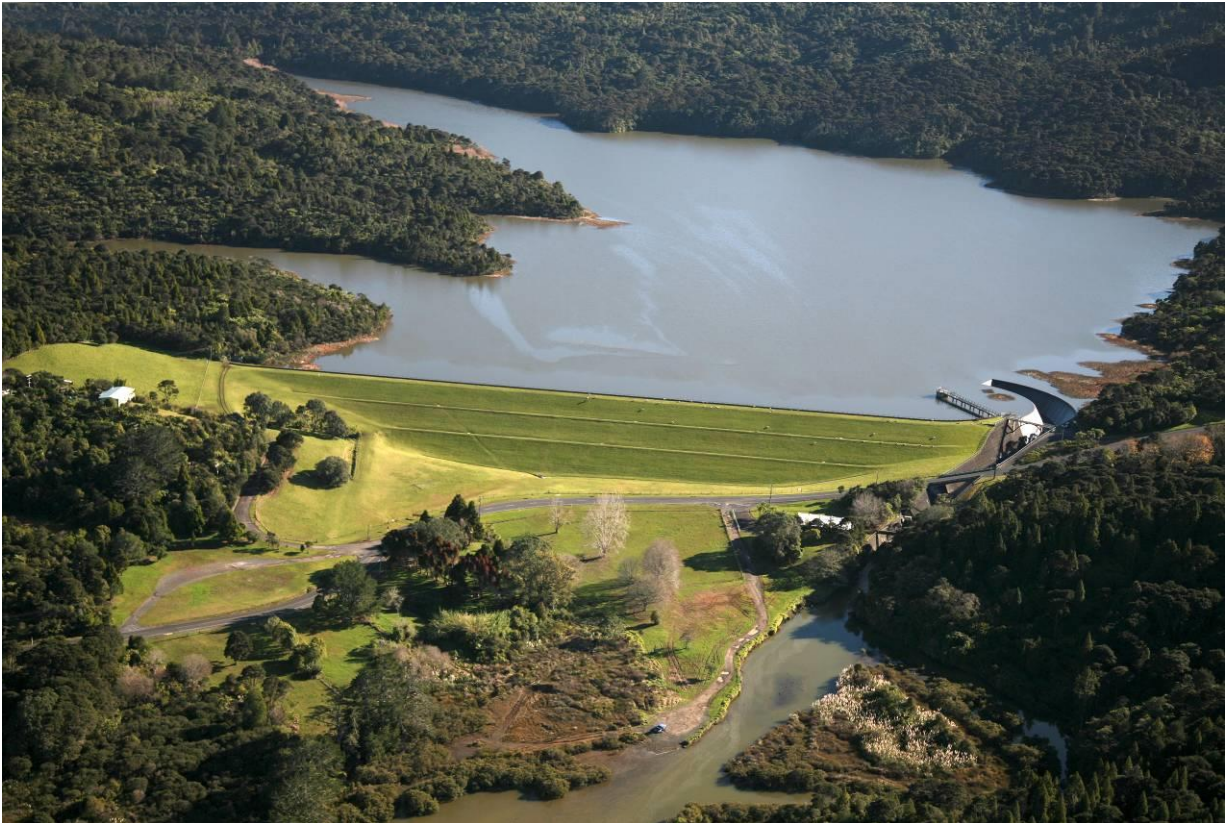
View of embankment, spillway and pump station
